# Archaeological Indications of Past Lifeways on the Krobo Mountain, Ghana

WILLIAM NARTEH GBLEKPOR<sup>1</sup>

## Abstract

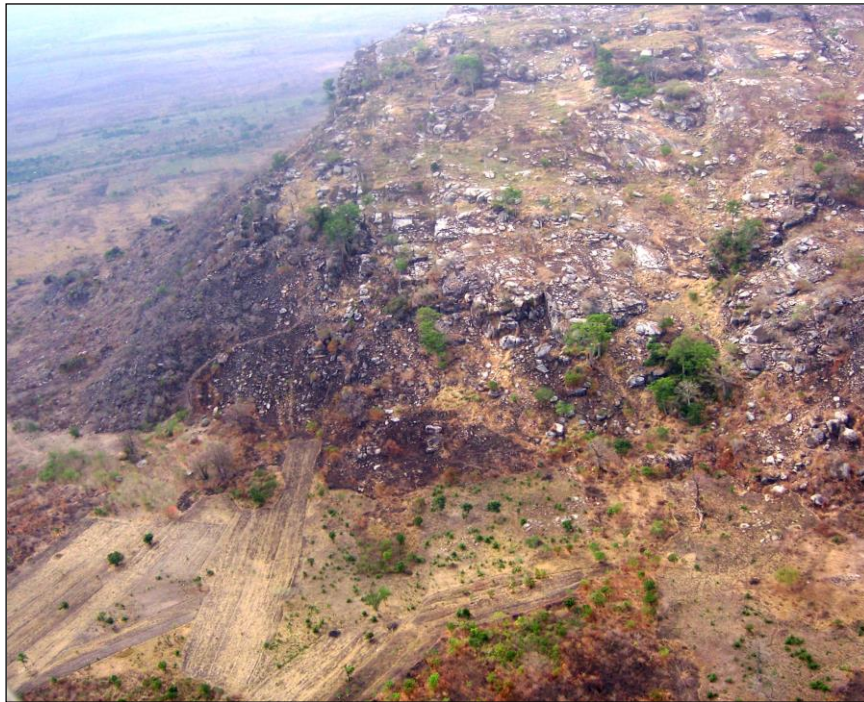
*Fig. 1: An aerial view of a portion of the south-western section of the Krobo Mountain (Photo by William N. Gblerkpor)*

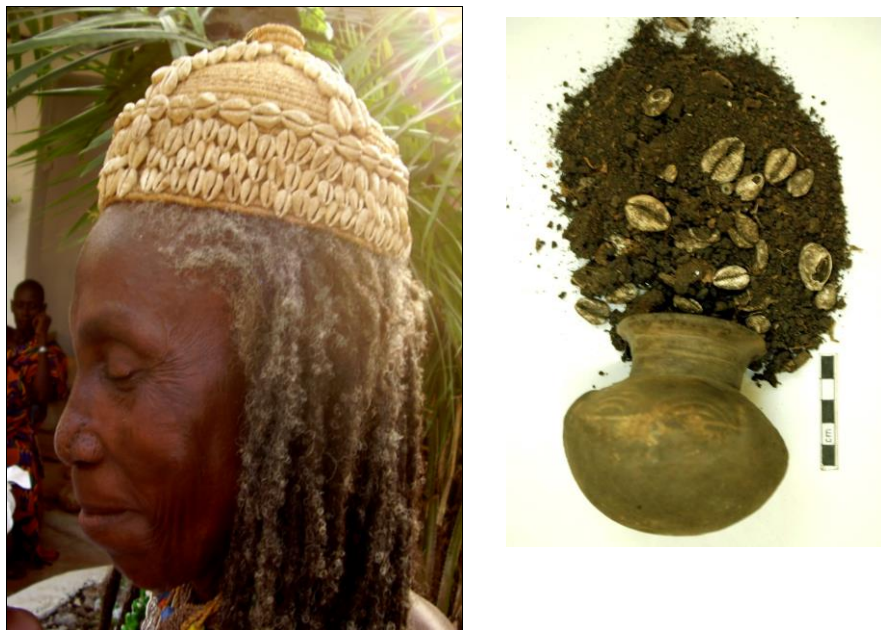
Fig. 3: Cowries recovered from the Krobo Mt. (left), and the Yilo Krobo state Priestess wearing a hat decorated with cowries [right] (Photos by William N. Gblerkpor)

The overall performance of the Krobo economy can be inferred from the numerous cowries and schnapps bottles (also used as currency in the past) that are found at the site (Figs. 3 and 11). The use of cowries as a medium of exchange was widespread in the Gold Coast (Bredwa-Mensah 2002: 160). At the beginning of the 19<sup>th</sup> century, the English were shipping about 100 tons of cowries to Africa annually. But with the abolition of the slave trade in 1807, their shipment dropped to an average of about six tons a year between 1810 and 1815. The cowrie trade however, recovered with the development of the palm oil trade. By the 1830s, between 60 and 100 tons went annually to the Gold Coast alone, and from 1835 at least 50 tons a year to the area that is east of the Volta. Later on in the 19<sup>th</sup> century, the *cypraea moneta* was replaced by the *cypraea annulus* in West Africa, and it (*cypraea annulus*) was accepted by the palm-oil merchants. By 1850 the Gold Coast was importing cowries at the rate of some 150 tons a year (Johnson 1970:49; York 1972: 96 - 98). Large numbers of cowries were traded in the Krobo Mountain as the inhabitants participated in the booming economy of the 19<sup>th</sup> century.

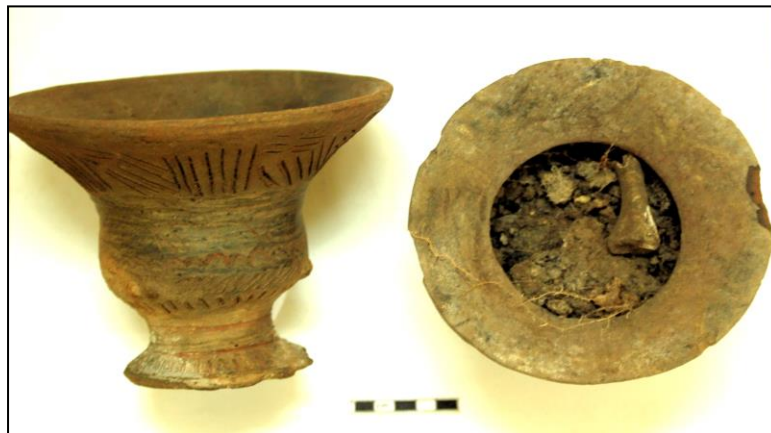
*Fig. 4: Ka-si-tsotsɛ, (dish with base, right) containing soil and a chicken bone  
(Photo by William N. Gblerkpor)*

Artifacts retrieved from the excavations and associated with indigenous religious activities include a terracotta figurine. These items served various purposes in the shrines. For instance, the *Ka-si-tsotsɛ* (vessel with stand) was used for serving porridge-like corn or millet flour solution, *mamu-nyu* to the gods. Glass beads of all shapes and colours as well as cowries have been collected from shrine contexts. The ethnographic information suggests that these beads and cowries were worn by traditional priests and priestesses of the Krobo. White-coloured beads, which signify purity in Krobo tradition, are the most preferred ones by indigenous priests and priestesses (Fig. 3). More than 2,150 19<sup>th</sup> century schnapps glass bottles representing about 90.0% and 28.0% of glass objects and total

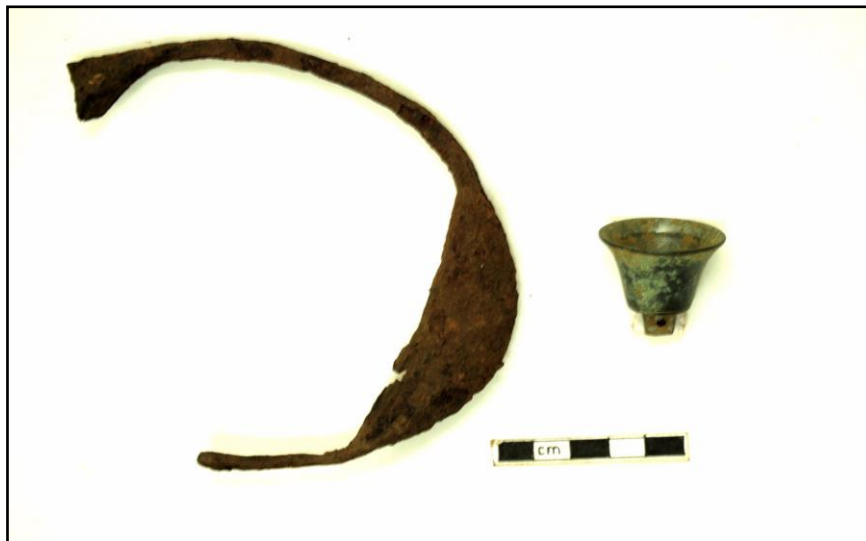
*Fig. 5: Ritual objects- an iron Anklet (left) and a miniature copper Bell (right) recovered from the Krobo Mt. (Photo by William N. Gblerkpor)*

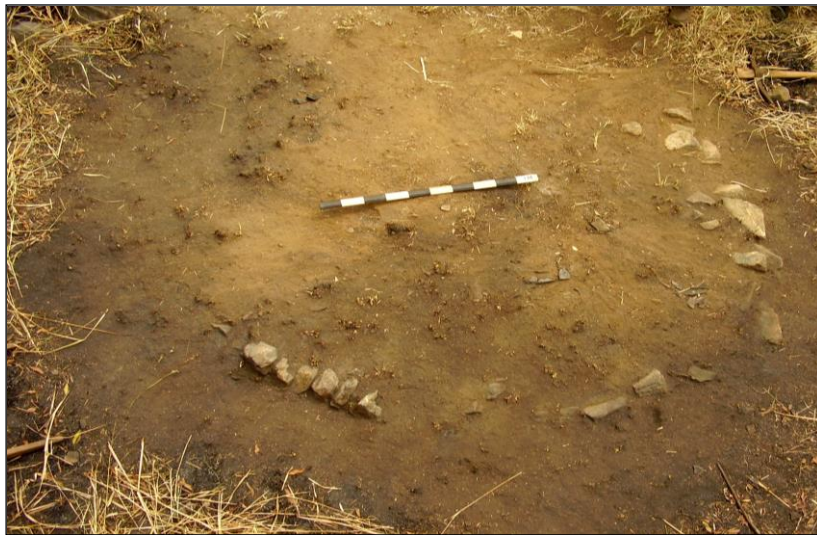
*Fig. 7: Remains of a shrine (hut) marked by stone blocks  
(Photo by William N. Gblerkpor)*

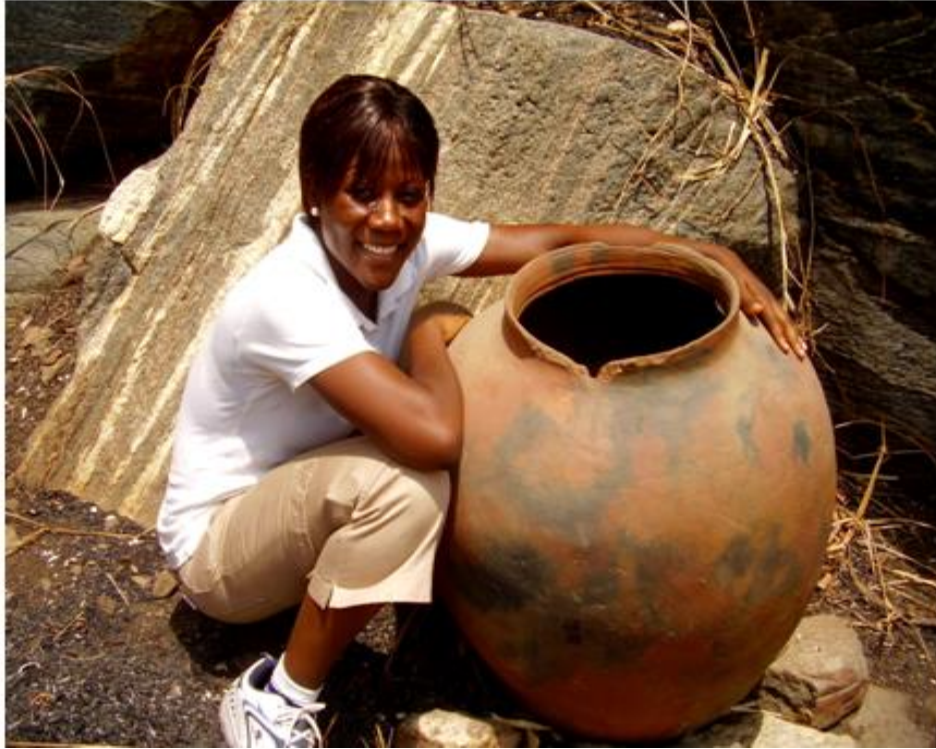
*Fig. 8: Didz, vessel for storing water (Photo by William N. Gblerkpor)*

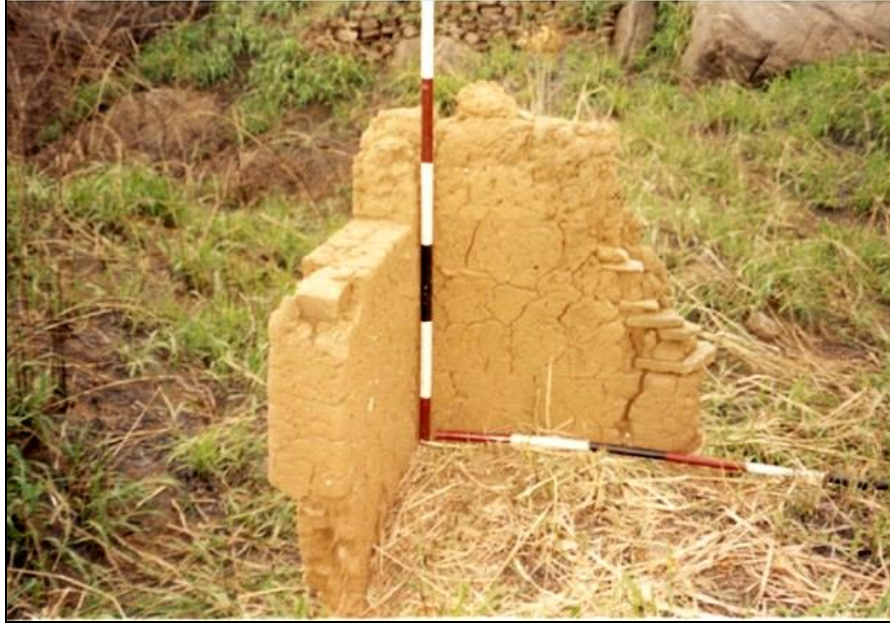
*Fig. 9: A stone-mud wall (Photo by William N. Gblerkpor)*

In addition to the terraces, two other walling styles were identified. The classification was based on the building materials used — swish and clay-stone (see Fig. 9 which is clay wall with a number of stone blocks fitted in the corners and other parts of the wall). The archaeological evidence indicates that the people used both clay, and stone masonry, with stone dominating as a construction material in the building ruins recorded. This is evident in the over 1200 stone structures as against 35 swish walls identified on the site, and this is understandable, since on the mountaintop, stone was (and is more) common than clay, the latter being the usual traditional building material in southern Ghana. It must also be noted that stone structures last longer than mud ones, which explains the relatively lower figures recorded for mud houses.

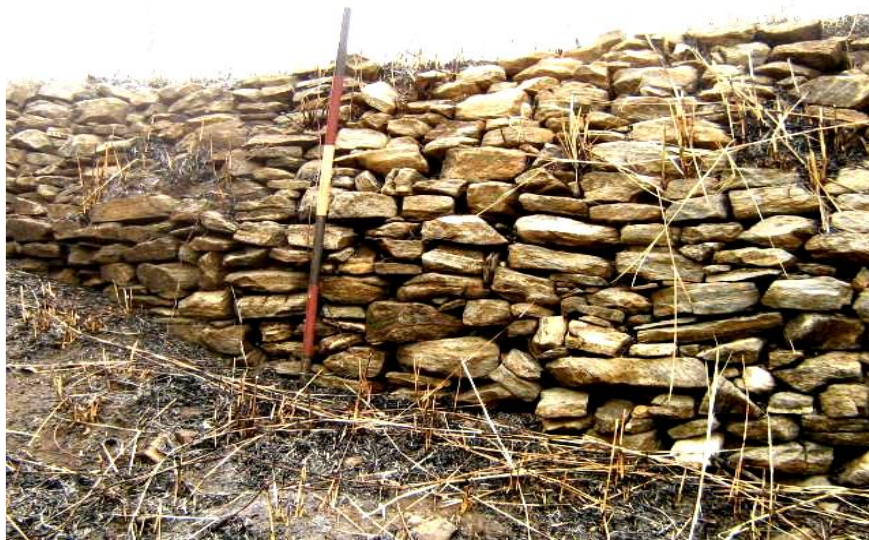
*Fig. 10: A Terrace Wall (Photo by William N. Gblerkpor)*

Three major types of terrace walls were identified: terrace walls that served as foundations, which directly supported stone and/or mud houses; terraces that served as retaining walls to check erosion ("hill-side erosion and gullying" [Anquandah 2006: 7]); and terraces that helped to level the steep sloping portions of the landscape to facilitate normal domestic activities and easy climbing (Fig. 10). The terraces provided the basic adaptive tool with which the people coped with the rugged mountainous environment. The abundance of naturally occurring stone made stone-terracing the most logical response to the demands of the environ-

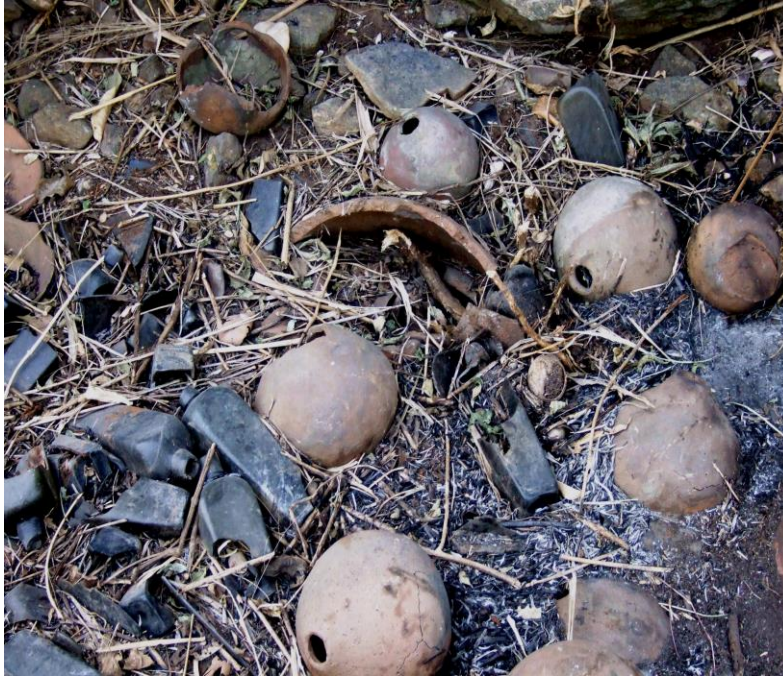
*Fig. 11: Schnapps Bottles and Mumui, a palm-wine tapping/storage vessels (Photo by William N. Gblerkpor)*

finds respectively were recovered. In addition to the liquor bottles, local pottery vessels, *mumui* and *likɔkɔ* (little clay cup) for tapping palm-wine and pouring of libation have been retrieved (Fig. 11). This suggests an extensive use of liquor by the inhabitants. Although social drinking may have contributed to the liquor collections, the constant association of these artifacts with shrines suggests their use in rituals and religious practices.

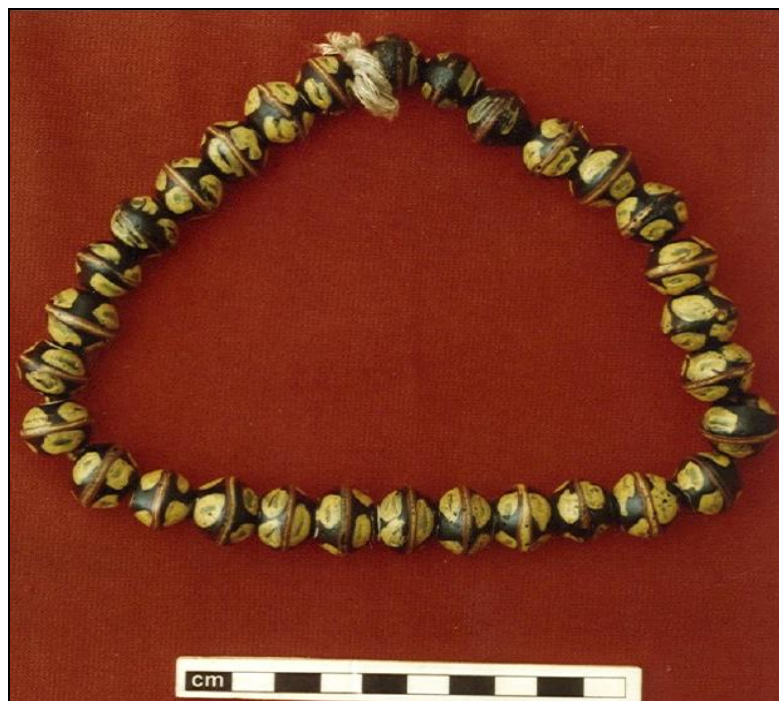
Figure 12: 19<sup>th</sup> Century Imported Glass Beads  
(Photo by William N. Gblerkpor)
