Impacts of flooding and riverbank erosion on the environment and socio-economic activities in the Lower Pra River Basin

Abstract

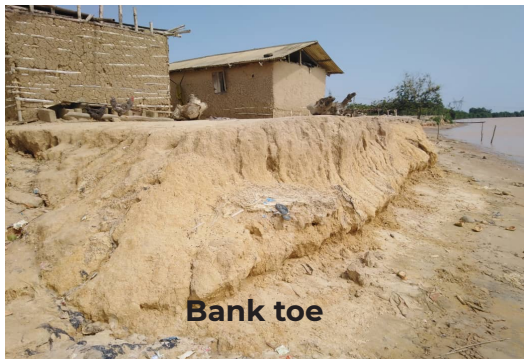
Fig. 2a: Buildings threatened by bank erosion at Bosomdo

The direct physical impact of riverbank erosion from field discovery was land loss along the riverbank which constitutes environmental degradation. Bank failure resulted in the uprooting of trees along banks into river channels. These logjams enhanced bank wearing at bank full. Other environmental impacts included the destruction of infrastructure and buildings. About 80% and 84% of respondents indicated that bank erosion damages infrastructure and properties, respectively. Infrastructure and personal properties being destroyed by bank erosion included roads and buildings. For instance, a tributary of the Pra River had heavily eroded the edges of a road linking Anlo Beach town and Krobo. When people's buildings collapse, personal belongings such as television sets, furniture and cooking utensils are destroyed. These individuals are dispossessed of their lands and therefore change occupation or become unemployed. Respondents in Bosomdo-Krobo admitted that they are highly exposed to bank erosion (Fig. 2a & 2b), and it is a substantial threat to their livelihoods as it has led to the collapse of their buildings and loss of household properties. Therefore, victims have had to relocate. Literature shows that riverbank erosion has had dire socio-economic ramifications such as loss of lands, rendered people homeless, displaced them and forced them to defer economic life in India and Bangladesh (Deکارaja & Mahanta, 2021, 2021; Islam & Rashid, 2011).

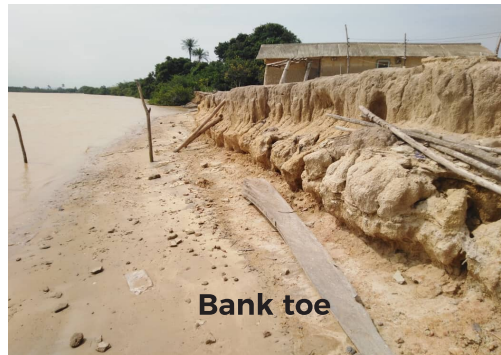
Fig. 2b: Building threatened by bank erosion at Krobo

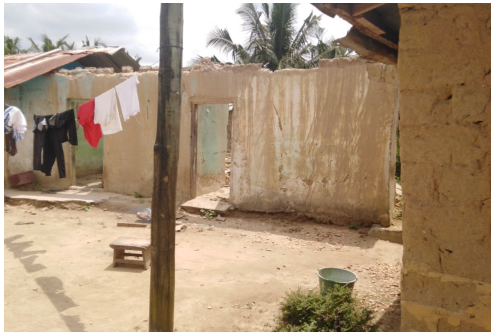
Fig. 3a: Collapsed building at Twansukoda in Twifo Praso

In relation to property and infrastructure, residents were highly impacted by flooding and the proportion of the people who expressed this opinion were 83% and 86% respectively (Table 3). They revealed and it was also observed that floods cause the destruction of buildings and household properties, accounting for immeasurable economic hardships that are very difficult to recover from in the short-term. Household items (television sets, cloths, and furniture) were destroyed by floods. Also, flood waters had damaged buildings in the riparian zone (Figs. 3a & 3b). Respondents also mentioned that during floods, their canoes and fishing gears get destroyed. Women explained that sometimes their fish processing tools, and smoking ovens built of mud/clay are washed away by floods. Also, roads are normally flooded or eroded cutting off flooded communities.

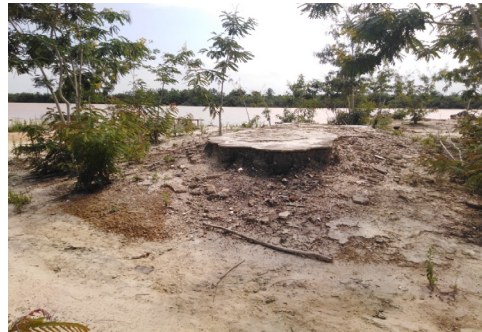
Fig. 3b: Residues of collapsed building at Krobo
